# **Technical Review of the Liulan Reservoir “7·6” Dam Failure Disaster in Hengzhou, Guangxi, China**

## **— Overtopping and Local Breach Development under Extreme Rainfall and Above-Standard Flooding: Processes and Broader Lessons**

Qizhong (George) Guo

Original version: July 8, 2026    Revised: July 25, 2026

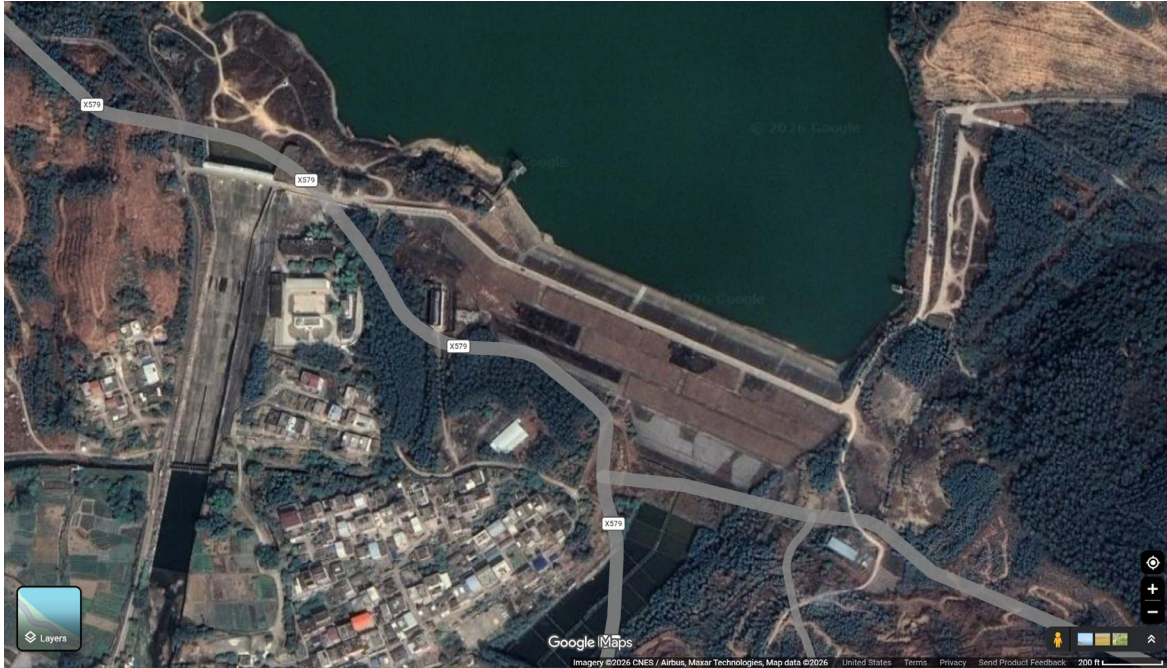
**Figure 1. Pre-Event Layout of Liulan Reservoir and Satellite Image of the Channel Near the East Abutment. The open bypass-like channel outside the abutment is visible on the right. Public reporting has associated it with a fuse-plug emergency spillway, but its formal function, control elevation, and relationship to the initial breach remain to be confirmed from design records and the investigation. Image source: Google Maps (imagery credits shown in the figure).**

As shown by the planform in Figure 1, the reservoir shoreline and dam axis form a degree of planform convergence near the east abutment, where a hillside channel and suspected emergency spillway are also present. This geometry alone does not prove the existence of high-velocity “funnel-like” flow immediately upstream of the dam, because reservoir flow near the dam is normally dominated by storage and relatively low velocities. However, if the east abutment contained a locally low crest or road elevation, a microtopographic depression, an abutment interface, or a downstream flow-guiding channel, overtopping flow could have concentrated there first. Once an initial gully or local collapse formed, a positive feedback could have developed: lower elevation → greater flow concentration → accelerated erosion → breach enlargement. This remains a testable hypothesis and should be evaluated using detailed topographic surveys, continuous imagery, and coupled two- and three-dimensional hydraulic and erosion analysis.

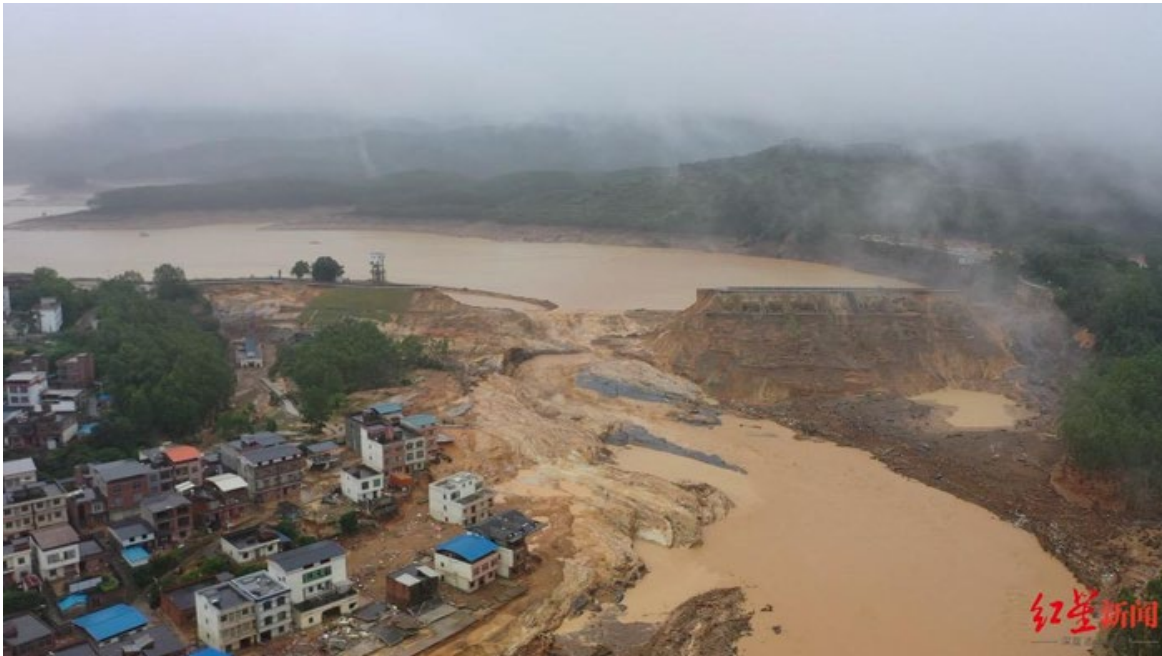
**Figure 2. Aerial View of the Dam Breach and Near-Dam Downstream Area after the Liulan Reservoir Failure. The image shows the large breach, sediment-laden outflow, and affected near-dam downstream area. It documents the overall post-event scene but cannot by itself establish the initial breach location, the precise sequence of overtopping and local breaching, peak discharge, or the specific failure mechanism. Image source: Red Star News, “The Critical 12 Hours before and after the Liulan Reservoir Breach: Those Trapped and Their Rescuers,” July 11, 2026.**

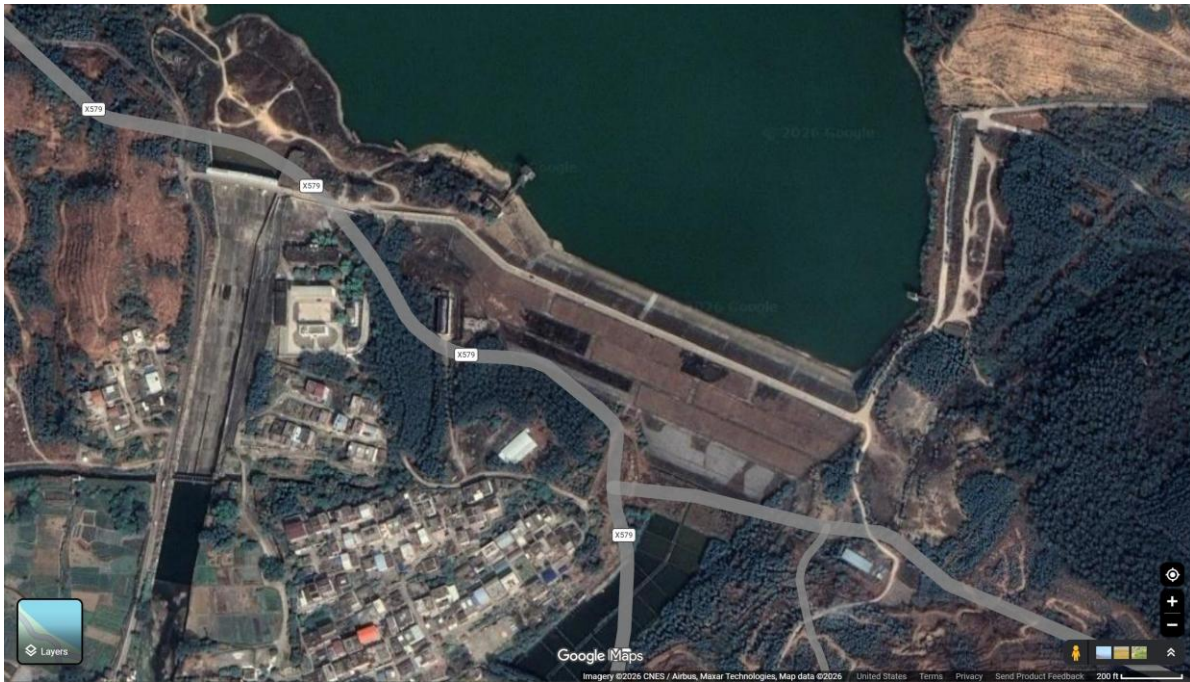
Another issue that should be carefully verified in the formal investigation is the engineering nature and actual operating condition of the open bypass channel outside the east-bank dam shoulder. Pre-breach satellite imagery

shows that a normal spillway can be identified near the right-bank dam shoulder of Liulan Reservoir. At the same time, there is another distinct open bypass channel outside the east-bank dam shoulder, with artificial shaping and features suggestive of an auxiliary release channel or emergency spillway channel (see figure). Because satellite imagery does not provide control elevation, crest structure, design discharge, or activation conditions, this article does not determine the engineering function of that facility. Online sources have also mentioned that Liulan Reservoir may have a fuse-plug-type emergency spillway facility, but its location, elevation, activation criteria, current condition, and relationship to the present breach have not been confirmed by authoritative sources. Subsequent investigation should determine whether this east-bank channel is an auxiliary spillway, emergency spillway, or another engineering feature; whether its design function, actual discharge capacity, and current condition meet design requirements; whether the highest water level in this event reached its activation condition; whether the downstream floodway has been occupied or obstructed; and whether it has any direct relationship with the breach openings. This article does not use this issue to characterize the event; it identifies it only as an important issue for subsequent engineering review.

*Figure: Pre-event satellite imagery of Liulan Reservoir engineering layout (Google Maps; imagery source: Imagery ©2026 CNES / Airbus, Maxar Technologies)*
