# Surface Calm, Hidden Currents

The New Reality of Recreation Safety on the Guadalupe River After the Flood

Based on the safety brief by Qizhong (George) Guo, Rutgers University (July 2026)

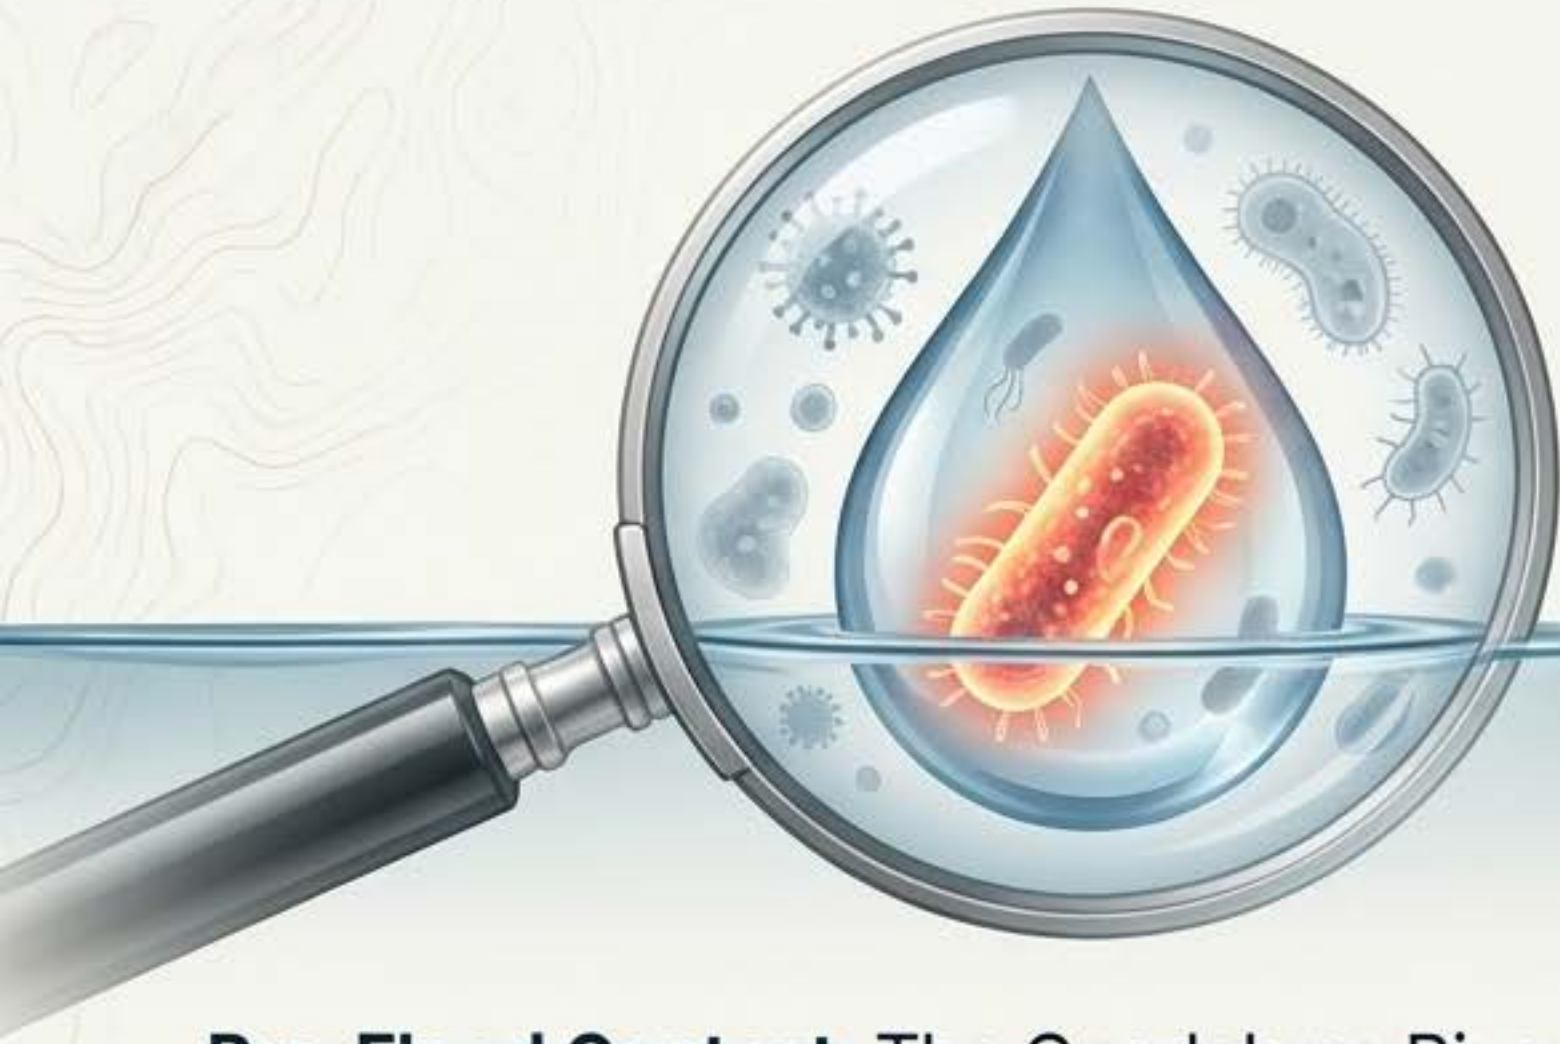
# Why We Test for E. Coli.

**The Canary Concept:** **E. coli** is rarely the primary pathogen of concern. It is the U.S. EPA's recommended **fecal indicator**—a reliable proxy signaling the potential presence of other disease-causing organisms.

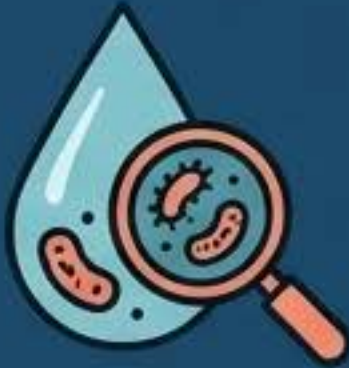
Less water means less dilution. Any bacterial input (septic leakage, wildlife) results in higher concentrations.

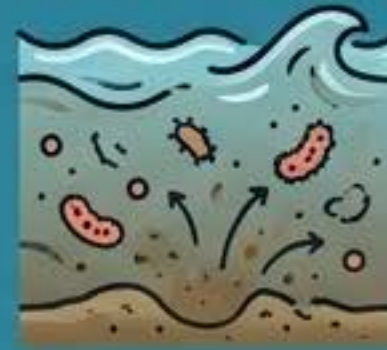
Heavy runoff resuspends contaminated sediment from the riverbed into the water column.

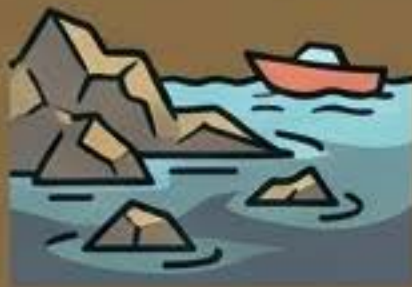
Exposes previously submerged rocks, ledges, and channel irregularities.

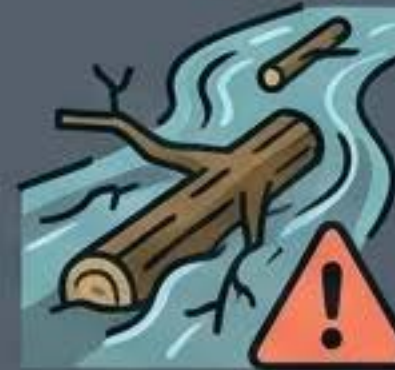
Creates stronger currents and mobilizes large, dangerous debris.

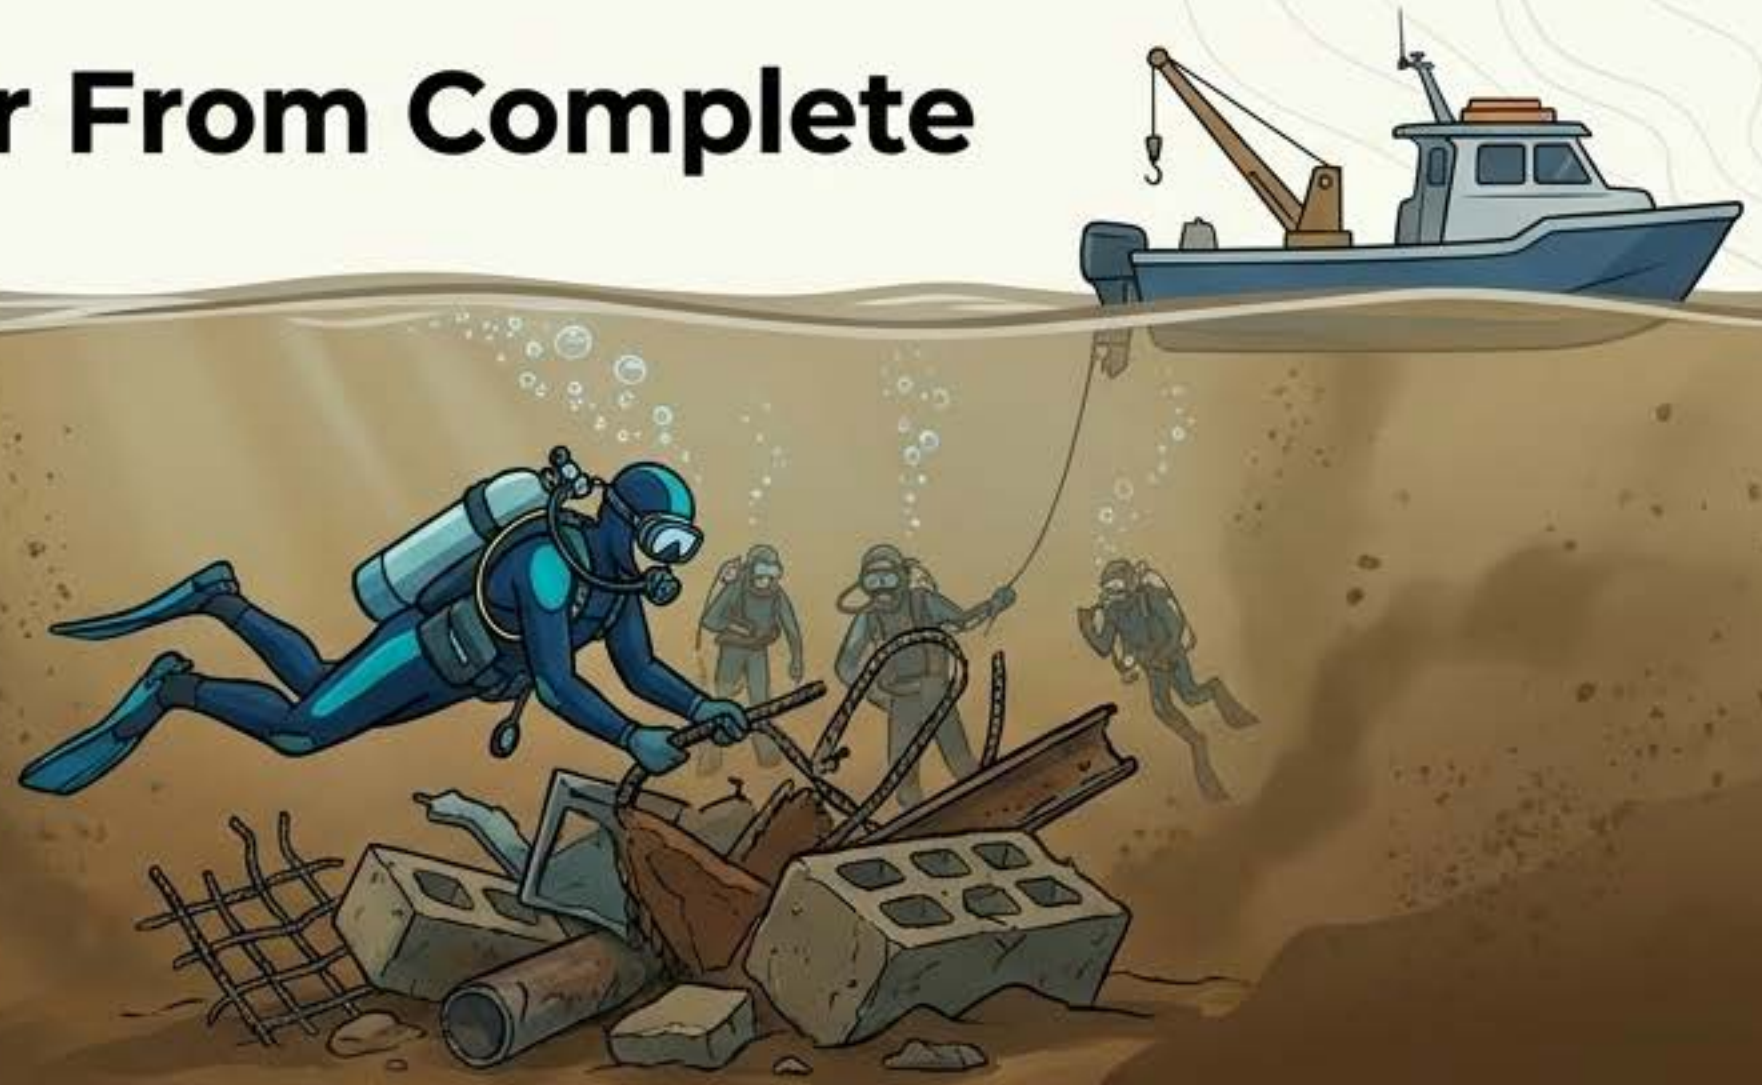
**The Effort:** Kerr Together funded a 90-day pilot project utilizing non-profit dive teams to survey and clear 20 high-contact recreation sites between Hunt and Center Point.

**The Reality:** Due to low visibility and extremely heavy submerged debris (including rebar and concrete), divers estimate full clearance of just these 20 sites could take up to two years.
