When a Homeowner Discovers a Dam

Infrastructure, Disclosure, and the Hidden Legacy of Small Dams

Qizhong (George) Guo
Professor, Civil & Environmental Engineering
Rutgers University – New Brunswick

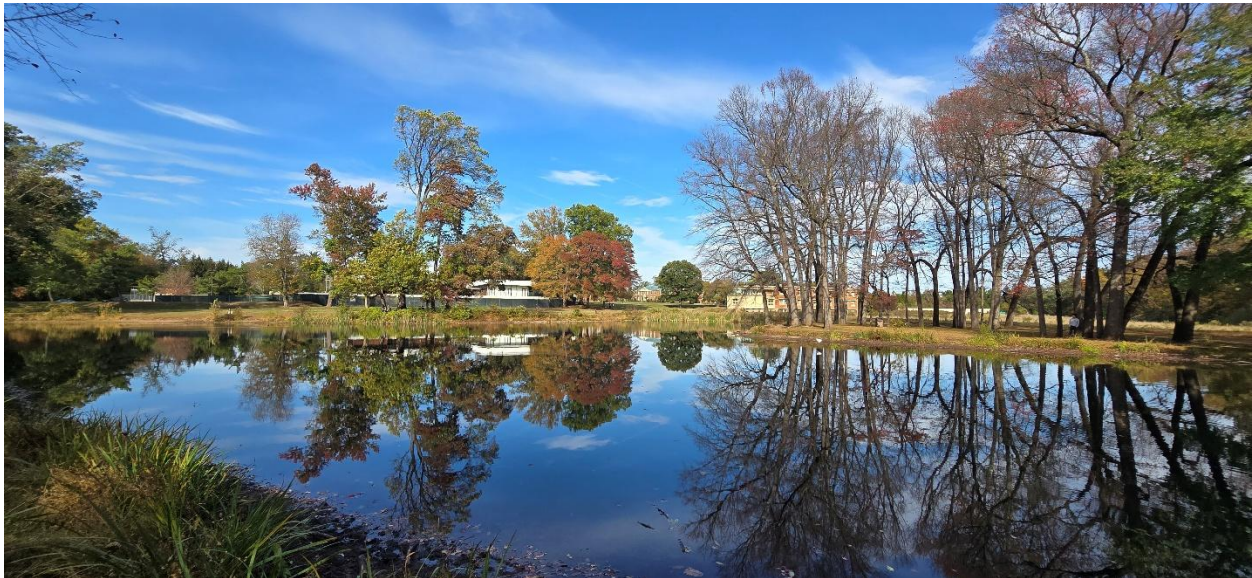
Figure 1. Overall view of the IAS pond in Princeton, New Jersey. While it appears to be a natural water body, the pond is in fact formed and maintained by a man-made embankment dam and outlet structure. (Photo by the author, October 18, 2025)

The pond behind the Institute for Advanced Study (IAS) in Princeton (Figure 1) provides an illustrative example.

Historical records indicate that the pond was constructed in the **mid-1960s**, likely as part of campus development and landscape design associated with nearby academic buildings.

- **1930s aerial photograph** → no pond present
- **1980s imagery** → pond clearly visible

This confirms that the pond is a **mid-20th century embankment structure**, rather than a century-old farm pond.

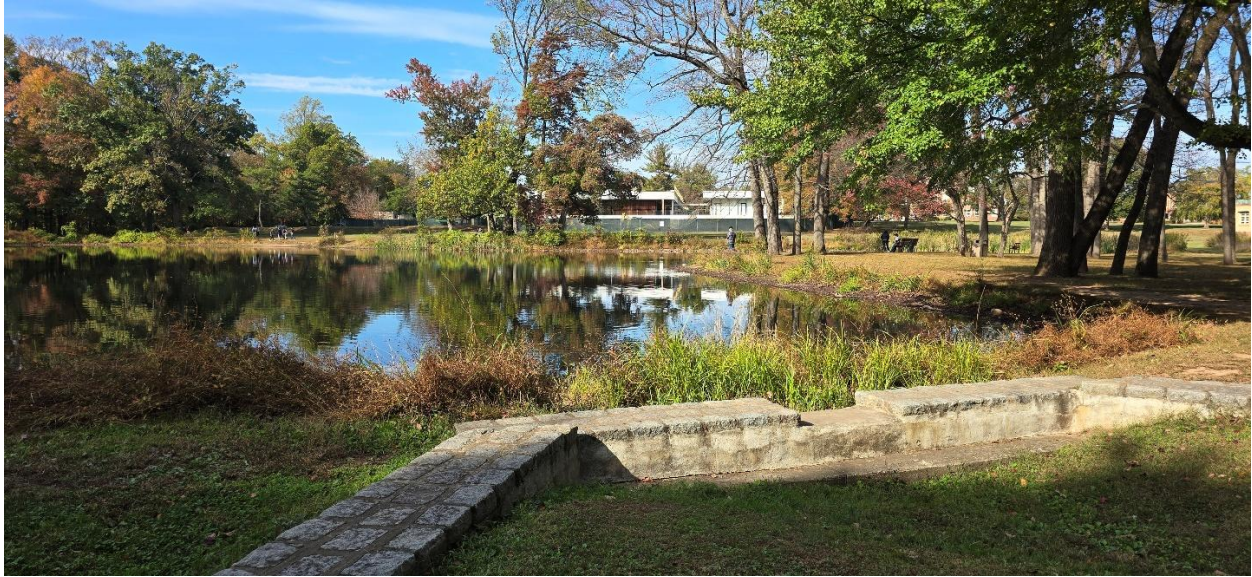
Figure 2. Outlet structure of the IAS pond showing controlled discharge (photo by the author, October 18, 2025).

- a **constructed outlet structure** (Figure 2)
- a **well-defined earthen embankment and crest** (Figure 3)

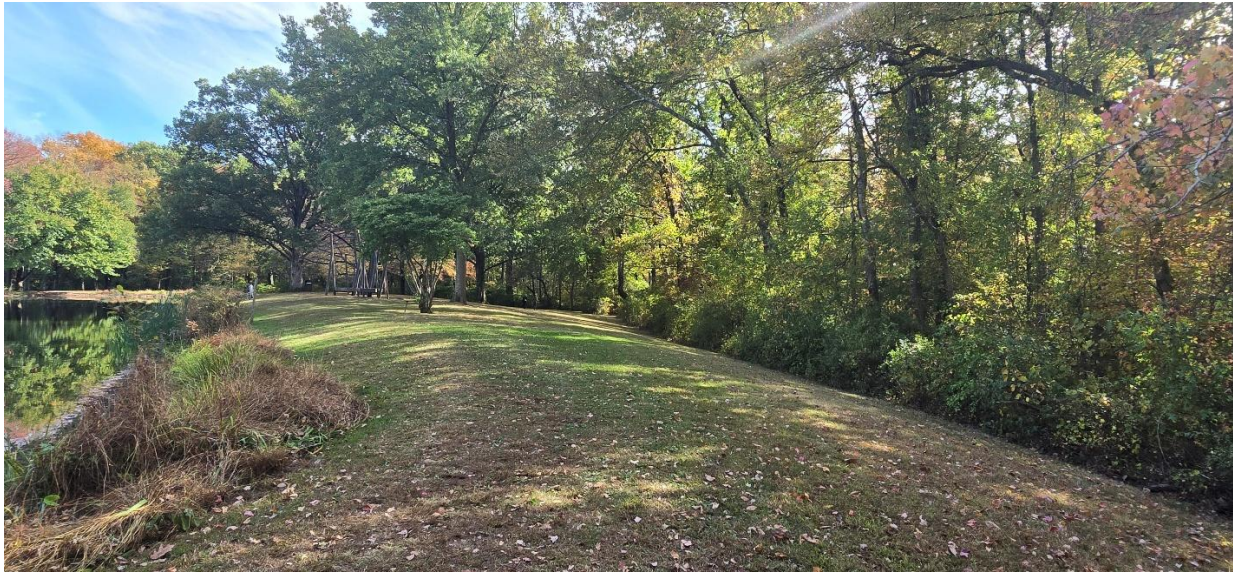
Figure 3. Earthen embankment (dam) of the IAS pond, showing crest and downstream slope (photo by the author, October 18, 2025).
